Please note that this advisory concerns school buses manufactured by Carpenter at the company's Mitchell, Indiana plant which closed in 1995.

### **Carpenter School Bus Advisory June 2003**

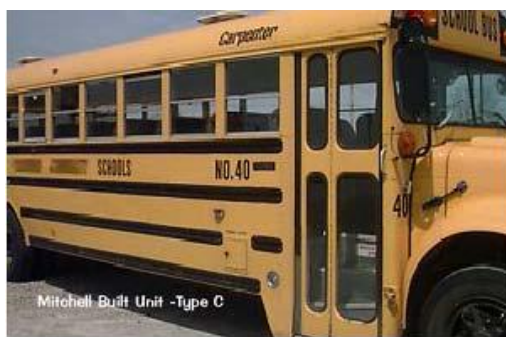
**Figure 1: Mitchell built type “C”**

2 There are noticeable differences between the rub rail locations for the two Carpenter plants. The rub rail at the floor line in all buses made at the Mitchell plant is interrupted at the wheel openings. The rub rail at the floor line in all buses made at the Richmond plant is continuous and is located just above the wheel opening. If the 6 digit body number starts with the number 4, then the bus was built in the Richmond, Indiana plant and utilized full length body bows.

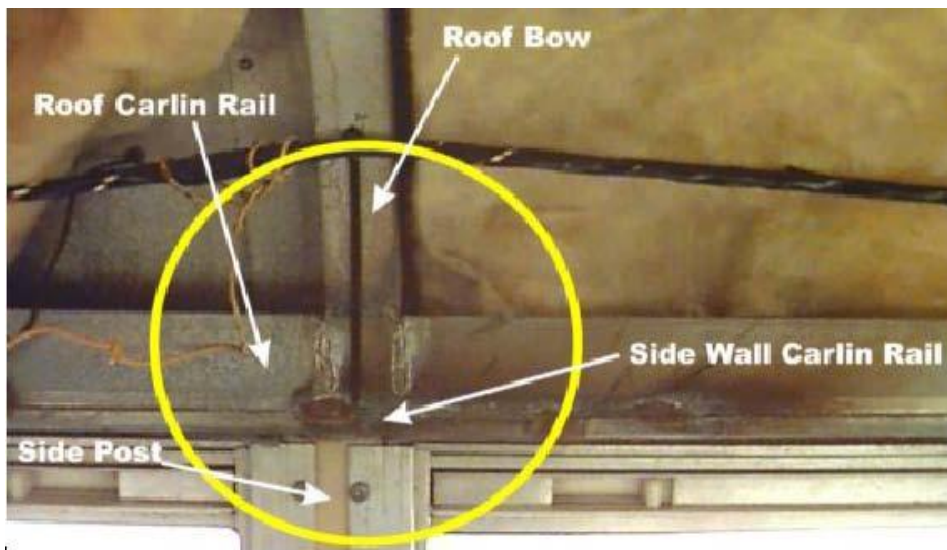
**Figure 5: Photo depicting weld locations**

At this time, we strongly encourage owners and operators of the Carpenter school buses described below to inspect them to determine if there are structural weld failures in the roof structure. The welds in question are located at the junction of the vertical side posts (between the windows) and the horizontal structural member (the “Carlin” rail) above the windows. The inspection will require the removal of interior panels as well as the removal of some of the windows. The following information is provided for your consideration and use:

3. All Carpenter school buses built in Mitchell, Indiana, no matter what the body number, should be inspected for cracked or broken welds in the roof structure. The photograph below shows the locations of the components that are welded together.

**NHTSA recommends that the following actions be taken with respect to any Carpenter school bus built in the Mitchell plant that has been found to have cracked or broken welds in the roof structure:**

**The bus should be taken out of service and replaced as soon as practicable.**

**If the bus must continue in use, the cracked or broken welds should be repaired as soon as possible by qualified service personnel.**

**In order to minimize the risk of a rollover, the bus should be used on routes that operate in low speed environments.**

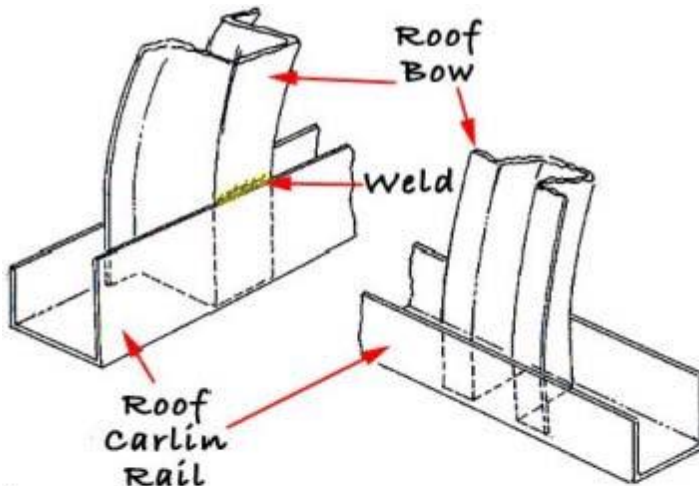
Figure 6: Roof bow weld locations

4. Two diagrams showing the components and weld locations are shown below:
